# TROLLEY WIRE

AUSTRALIA'S TRAMWAY MUSEUM  
MAGAZINE

AUGUST 2015

No. 342 Vol. 56 No. 3 - ISSN 0155-1264

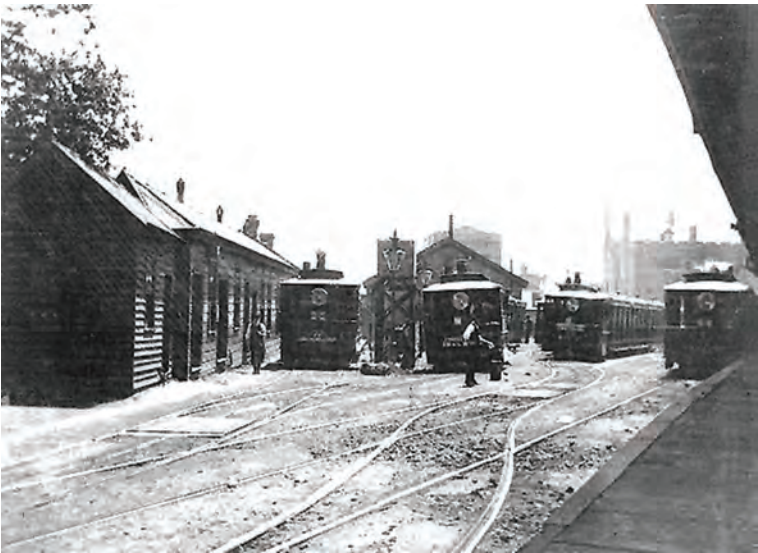
Bridge Street yard was the northern terminus of the steam tramway. The steam motors took on water from two tanks seen here between the two motors on the left. STM Archives

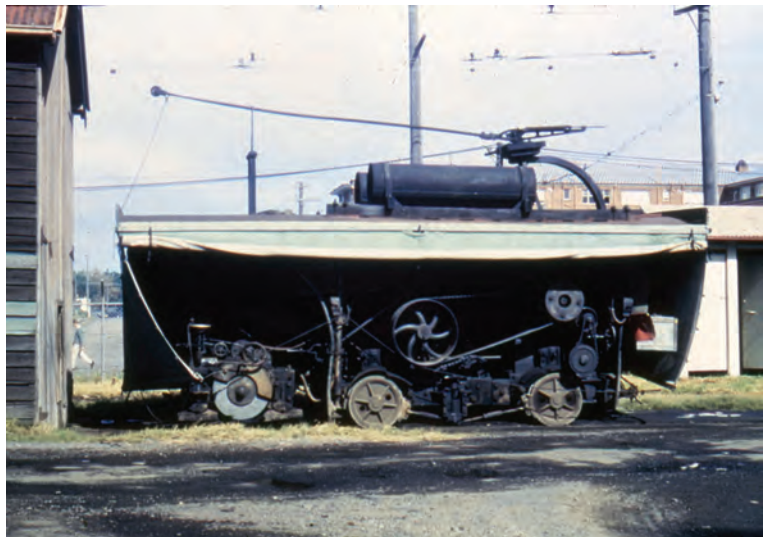
*A side view of the Woods Gilbert rail planer at Randwick Workshops. V.C. Solomons*

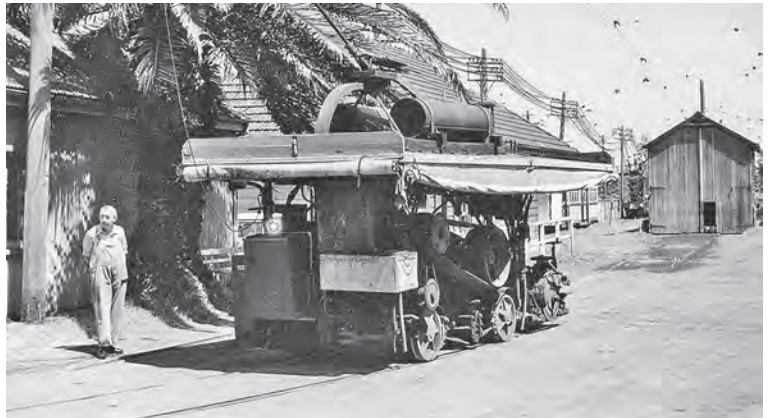
*A rear view of the Woods Gilbert rail planer at Randwick Workshops.* B.G. Tooker

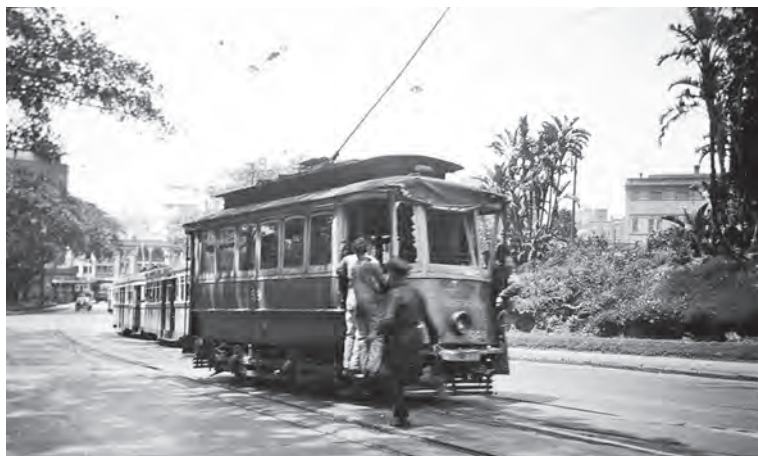
*C class breakdown car 59s about to be driven to Randwick workshops after its collision with 1977 on 25 November 1948.*  
John Burgess

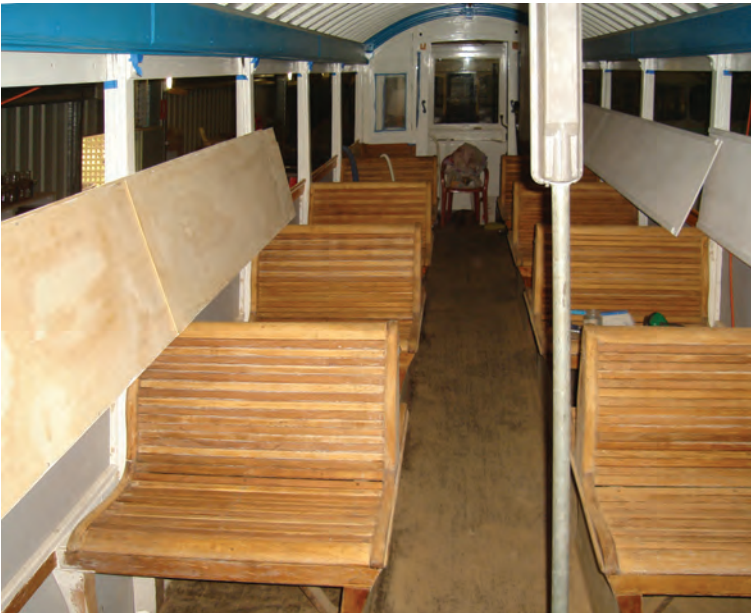
*Although painting of the interior of Dreadnought 136 is almost completed, the laborious task of removing many layers of paint from the seats in preparation for re-varnishing continues. The long white panels are the advertising boards about to be placed above the windows.*

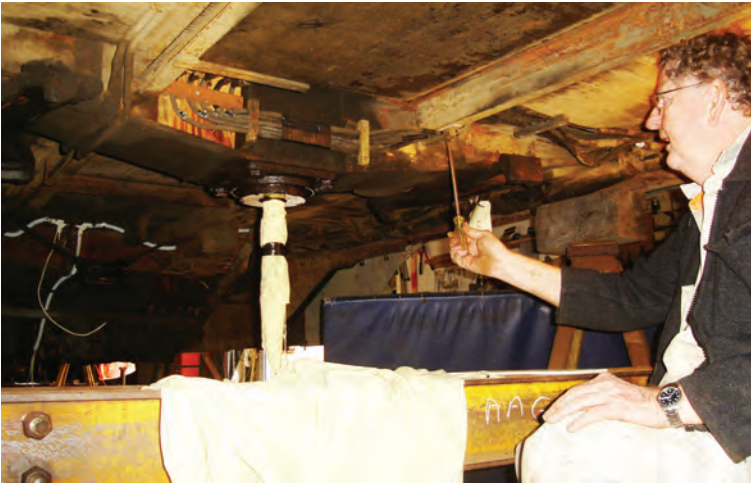
John Hudson is hard at work on the traction motor leads underneath FM400. The bogie kingpin has been wrapped in light cloth as a warning against bumping into it.
